Problem Report Briefing

**FANS Interoperability Team Meeting
(FIT/22)**

Santiago, Chile, 3-4 March 2015

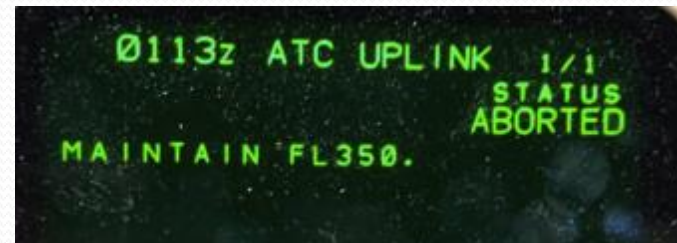
ATC UPLINK Page

- Most recent event was reported by Isavia and involved redisplay of MAINTAIN FL350 (PR-1823-SN)
 - Believe this to be 2nd event category (log from previous flight not cleared or redisplayed)
 - Flight crew could not respond (message status was ABORTED)
- Event is currently being investigated by the ISAVIA Safety Occurrence Group

- Boeing released a Fleet Team Digest (FTD) with the following guidance:
 - 1) During preflight, check the ATC log and manually clear any messages which may be present
 - 2) After landing, cycle the FMC circuit breaker to clear the memory- this has not been adopted by many airlines due to the increase in workload for the maintenance crew
 - 3) Check time stamps for all CPDLC messages

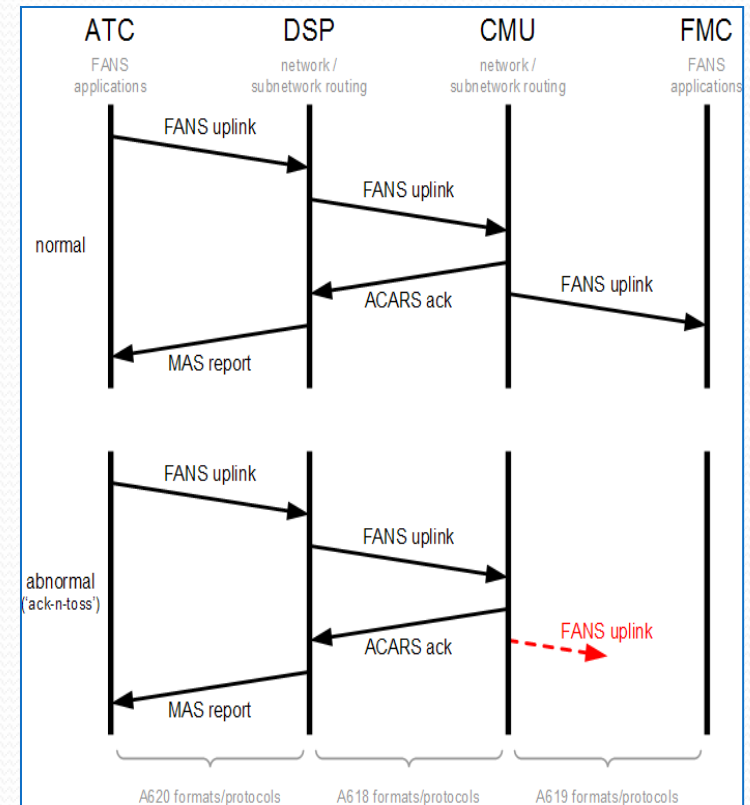
- CRA has received many, many reports of avionics ack'ing receipt of uplinks, but uplinks not being delivered to FANS applications in FMC
 - Ref PRs 1198, 1313, 1522, 1684, 1753, 1769, 1802
 - Also several reports from FAA DCL trials
 - Reported events involve B767s, B744s, MD-11s
 - Common denominator is Rockwell-Collins CORE -012 CMU
- CRA working with Boeing, Honeywell, Rockwell-Collins, and a B744 operator
- **B744 operator requested Boeing solicit input/help from other affected operators**
 - If event suspected, please provide CVR datalink recording log to Boeing
 - **B744 operator has made crew procedure available**
