**FANS Interoperability Team Meeting
(FIT/21)**

**Papeete, Tahiti
4-5 March 2014**

Performance Based Communications and Surveillance (PBCS)

Presented by Airways New Zealand

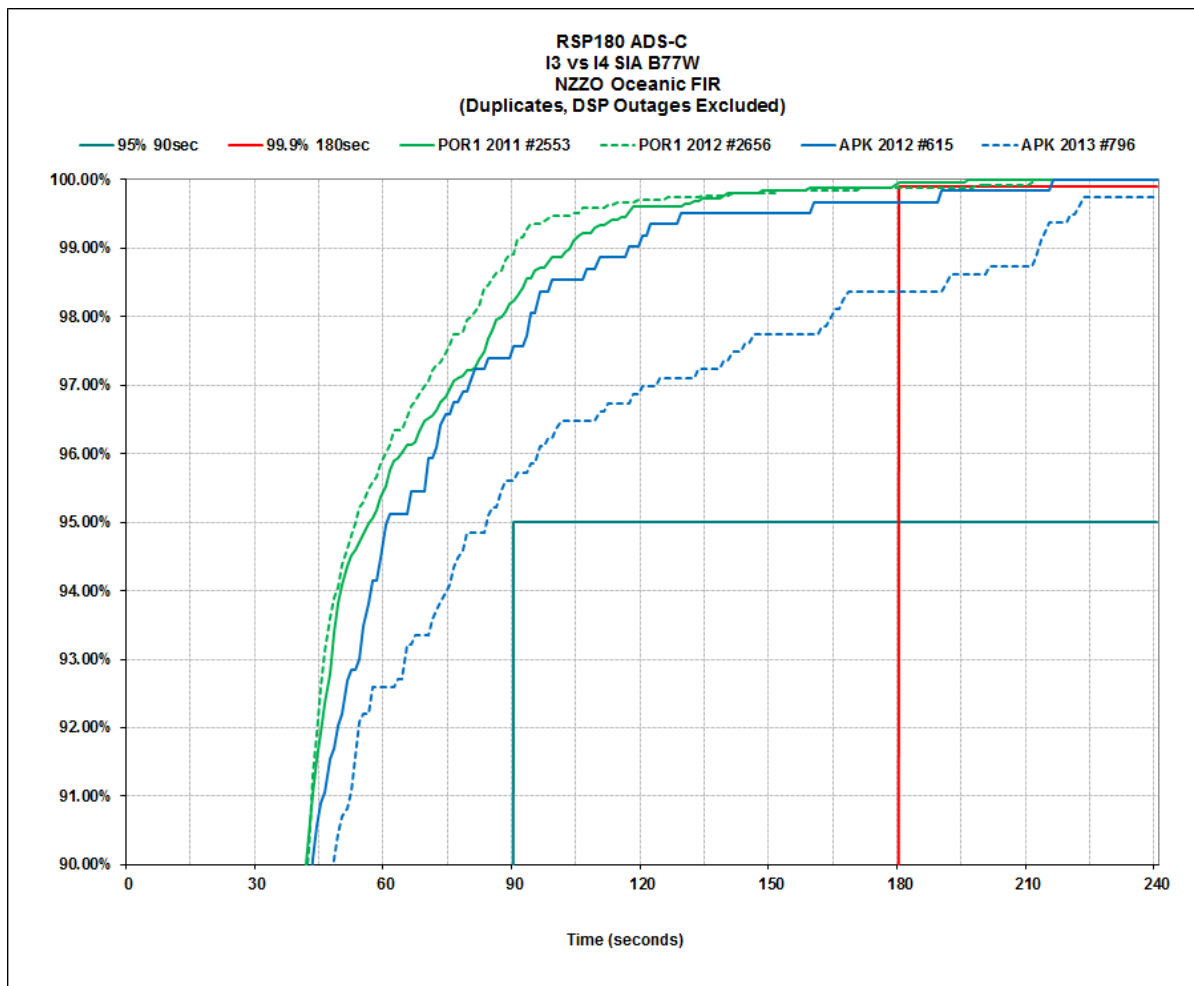
- 2.1 In September 2013 analysis of the August performance figures detected an apparent deterioration in performance of aircraft using the I4 satellite. In September 2013 Air New Zealand requested monitoring of the performance of their B77W fleet as they transitioned the aircraft to the Inmarsat I4. Analysis of the September and October data for these aircraft showed a significant deterioration below that expected and further investigation showed that all I4 traffic was being affected. Analysis of all fleets operating on the I4 showed consistent performance deterioration as indicated in the table below.

2.2 An analysis of data from the SIA B77W fleet 2011-2013 (refer Figure 1 below) clearly showed deterioration in performance in 2013. SIA had been one of the first fleets to transition to the I4 in NZZO airspace in 2012.

Figure 1: ANZ B77W I4 - September October 2013

2.3 A FANS problem report was raised on the CRA website on 25 November. Feedback to the PR was swift and Inmarsat advised that the observed deterioration had been caused by a software fault in a software package released into operation on 12th August that was causing all AES operating on the Pacific I4 to be allocated to a low speed 1200bps channel. Inmarsat also advised that the fault had been rectified on 20 November which was confirmed by subsequent analysis.

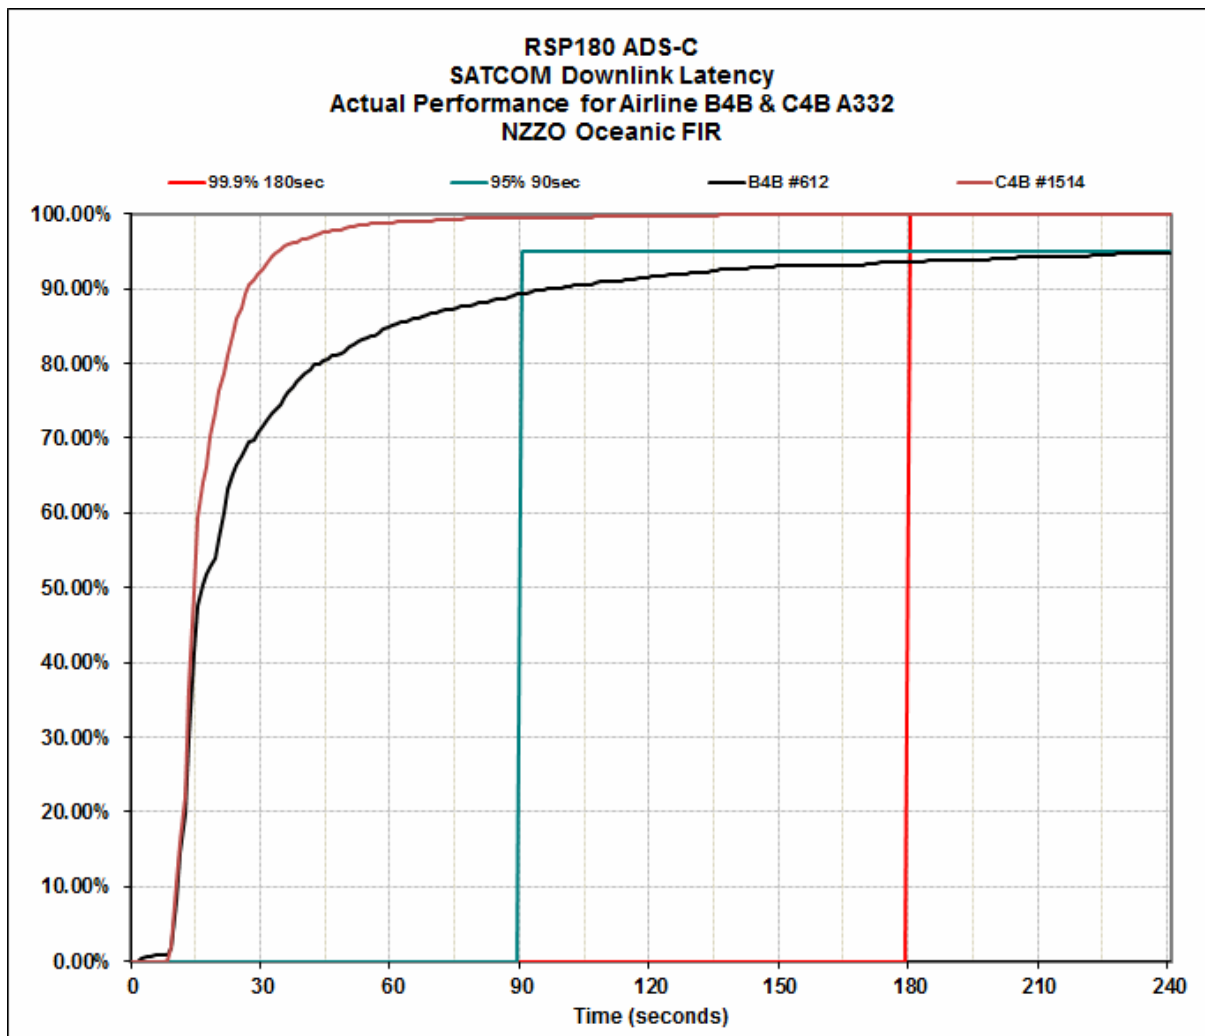
2.4 In early 2013 a new A332 fleet was introduced into the SOPAC. Monitoring of RSP180 and RSP240 performance from this fleet which had been incentivized by numerous controller complaints of sub-standard performance confirmed controller assessments. The observed performance is depicted in Figure 2 which illustrates typical performance from another A332 fleet (C4B) and the below par performance from the new fleet (B4B). The degraded performance falls below the normal operating 95% 90 second performance level. We have observed in the past that controller complaints of poor performance will be heard when performance falls below the 95% 90 second level and this occurred in this example.

Figure 2: New fleet operating below RSP180 standard

2.5 Airbus investigation determined that the aircraft had been set-up to use HFDL in the Airbus next-on-busy mode. Unfortunately, the airline was not an ARINC customer and any messages downlinked by HFDL were promptly discarded. Additionally, the airline had not registered to use the Inmarsat I4 service so the aircraft AES was being rejected from the I4 back to the I3. We had seen similar I4 registration problems on an A388 implementation and the performance impact is quite significant.

- 2.6 This issue generated three CRA problem reports. Two from Air Services and one from ourselves. The performance issues are now resolved with HFDL de-activated and the aircraft operating on the Inmarsat I3.
