**Twenty Third Meeting of the
Informal South Pacific ATS Co-ordinating Group (ISPACG/23)**

AIDC TRUNCATION ISSUES

(Presented by Airservices Australia)

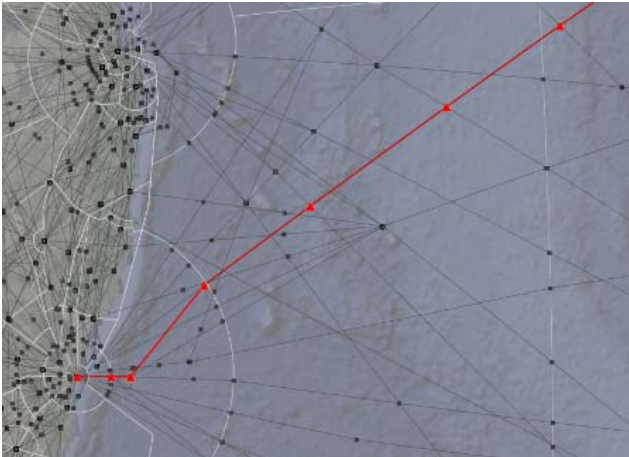
Figure 1 shows the originally flight planned route of the aircraft. **Figure 2** shows the route after processing of the ABI. This route has been incorrectly truncated by an upstream FIR (the route details have been simply deleted from the FIR boundary onwards). The route details now held by Brisbane are from the FIR boundary direct to destination. This type of gross error is relatively easy to detect by the receiving controller.

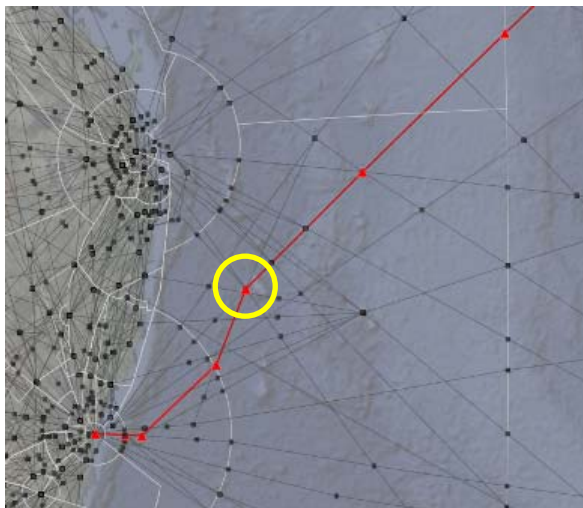
Figure 3 shows the originally flight planned route of the aircraft. **Figure 4** shows the route after processing of the ABI. This route has been incorrectly truncated by an upstream FIR (the waypoint "MISLY" (yellow circle) has been simply deleted). The route details now held by Brisbane are from TABAL direct to GORDO. This type of subtle error is difficult to detect by the receiving controller, especially in a UPR environment where the aircraft can actually flight plan such a route.

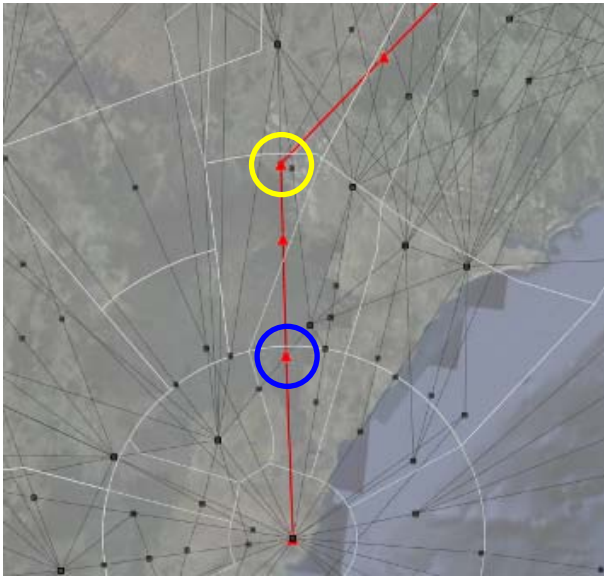
Figure 5 shows the originally flight planned route of the aircraft. **Figure 6** shows the route after processing of the ABI. This route has been incorrectly truncated by an upstream FIR (the route “CORKY H39 SY YSSY” has been replaced with CORKY (yellow circle) YSSY). The route details now held by Brisbane are from CORKY direct to YSSY. This route is fully within radar coverage, and there has been no change to the actual trajectory that the aircraft will fly. But this subtle change has removed BOREE (blue circle) which is a sequencing “feeder fix” for flights arriving at Sydney.
