# CRA Activities in Fukuoka FIR

ISPACG/31\_FIT/24

6-9 May, 2017

JCAB

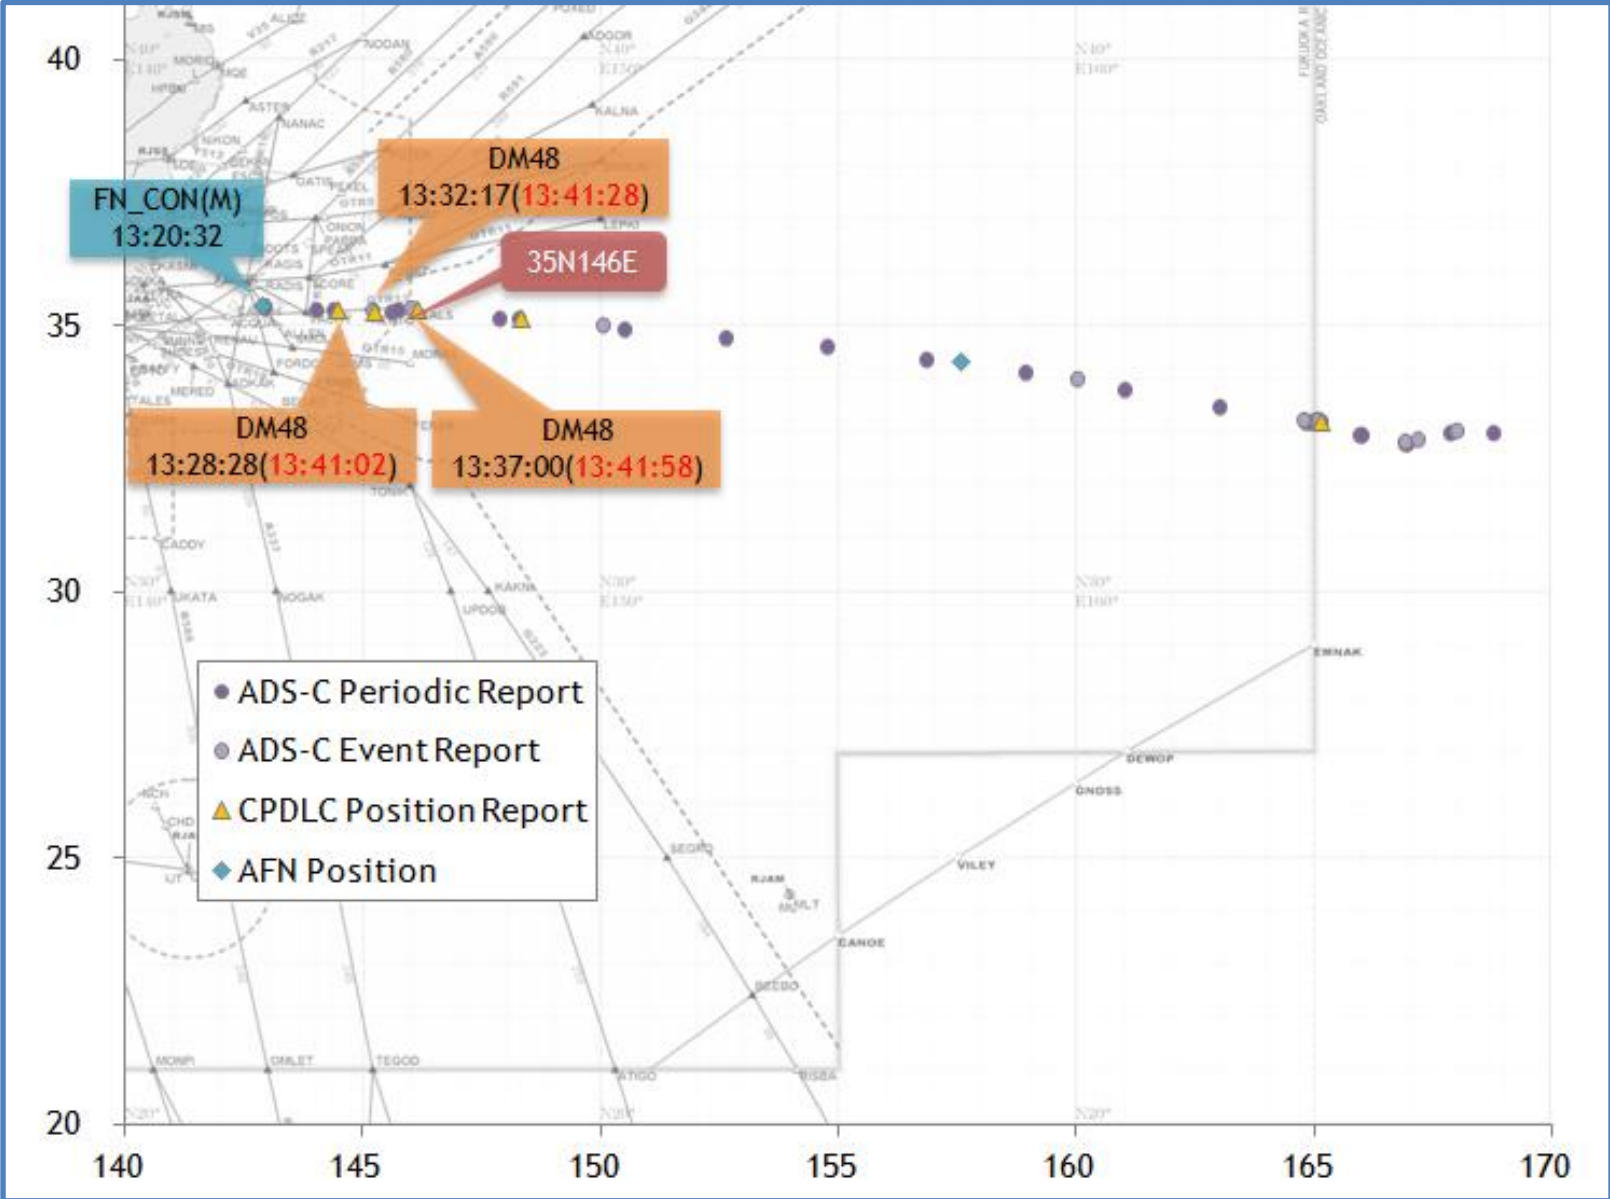
<Case:1> (#1221)

When performing the position report, “UNABLE TO SEND MSG” was displayed on the CDU. According to MOC’s advice, the crew reset the CCB.

- It was confirmed that the delay of the CPDLC message and the ADS-C report had occurred from 13:28 to 13:40.
- It seems that “UNABLE TO SEND MSG” was displayed just around that time.
- According to the AOC message, it seems that the CCB reset was performed around 13:45. However, since the ground system received the delayed downlink message before 13:45, it is considered that the CCB reset was not the reason why the situation improved.
- Since the media switched just around 13:28, it might not have been able to send messages temporarily.

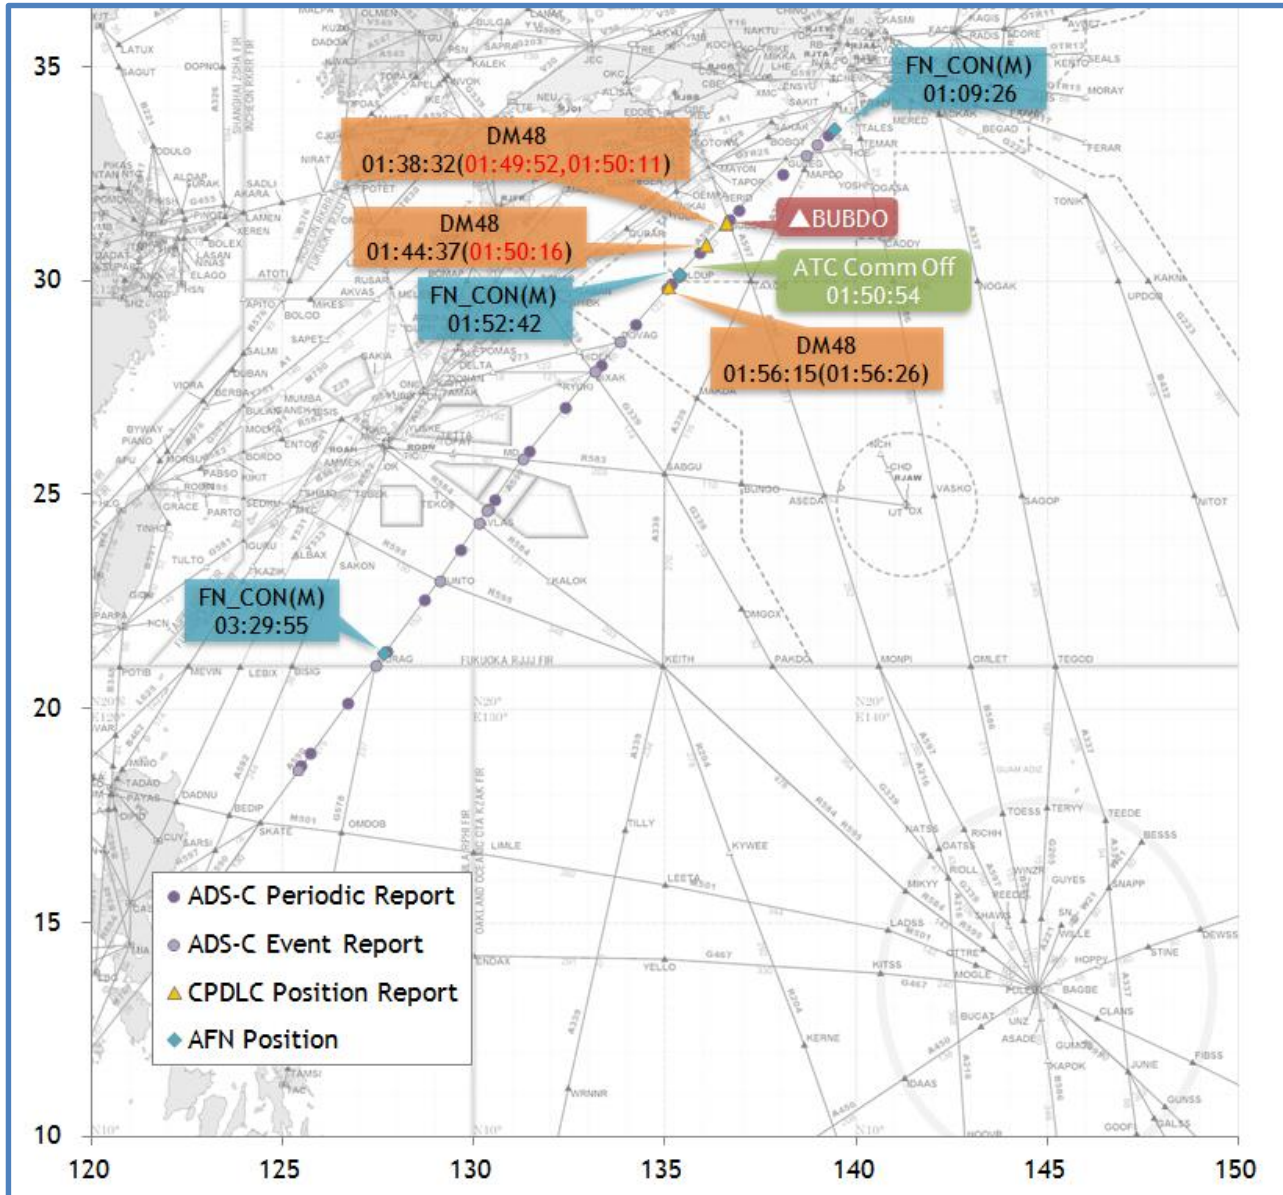
<Case:2> #1222

After passing BUBDO with CPDLC logged on to RJJJ, the crew sent a position report, but “UNABLE TO SEND MSG” was displayed. They attempted to send again but the situation did not change. So they logged off and performed the position report by voice communication. After a while, they logged on again and the position report was successfully sent.

- It was confirmed that the delay of the CPDLC message and the ADS-C report had occurred from 01:38 to 01:50.
- It seems that “UNABLE TO SEND MSG” was displayed just around that time.
- According to the communication log, log off and re-logout were performed around 01:50. However, since the ground system received the delayed downlink message before 01:50, it is considered that re-logout was not the reason why the situation improved.
- Since the media switched just around that time, the communication state might have been unstable.
