Airbus Status

ISPACG38/FIT31

June 2024

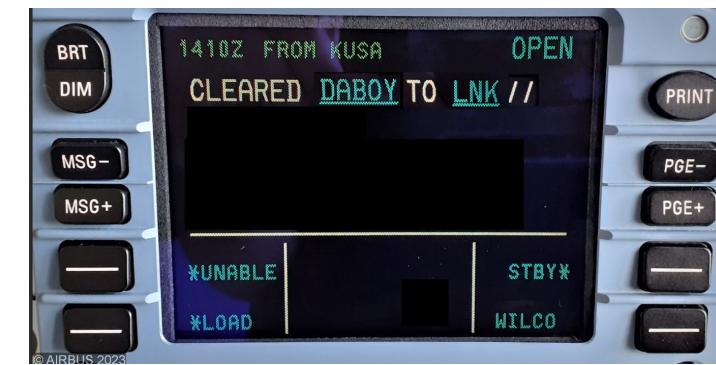
UC1 - Simple enroute UM79

1431Z FROM LFDG
CLEARED DABOY TO LNK //
REST OF ROUTE UNCHANGED//

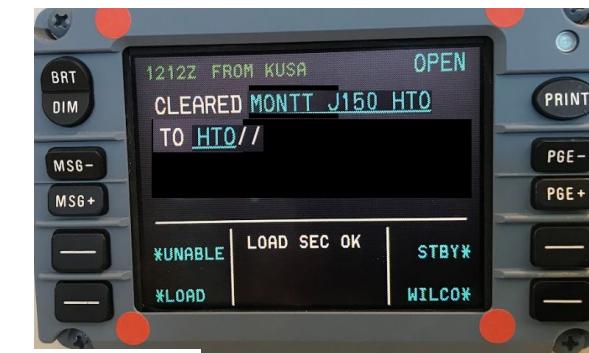
UC2 - Enroute UM79 with Airway and repetition of [Position]

1431Z FROM LFDG
CLEARED DABOY Q29 LNK
TO LNK //
REST OF ROUTE UNCHANGED//

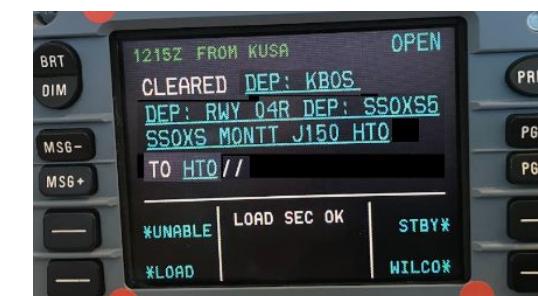
UC3 - Ground UM79 with [DepartureData], Airway and repetition of [Position]

1434Z FROM LFDG
CLEARED FROM: KJFK
DEP: RWY 19R DEP: CLTCH3
WEVEY EMJAY J174 WARNN
TO WARNN //
