**Twenty Eighth Meeting of the  
Informal South Pacific ATS Co-ordinating Group  
(ISPACG/28)**

**Agenda Item 5.1 Seamless Airspace**

**FMC WPR in YBBB**

**Presented by Airservices Australia**

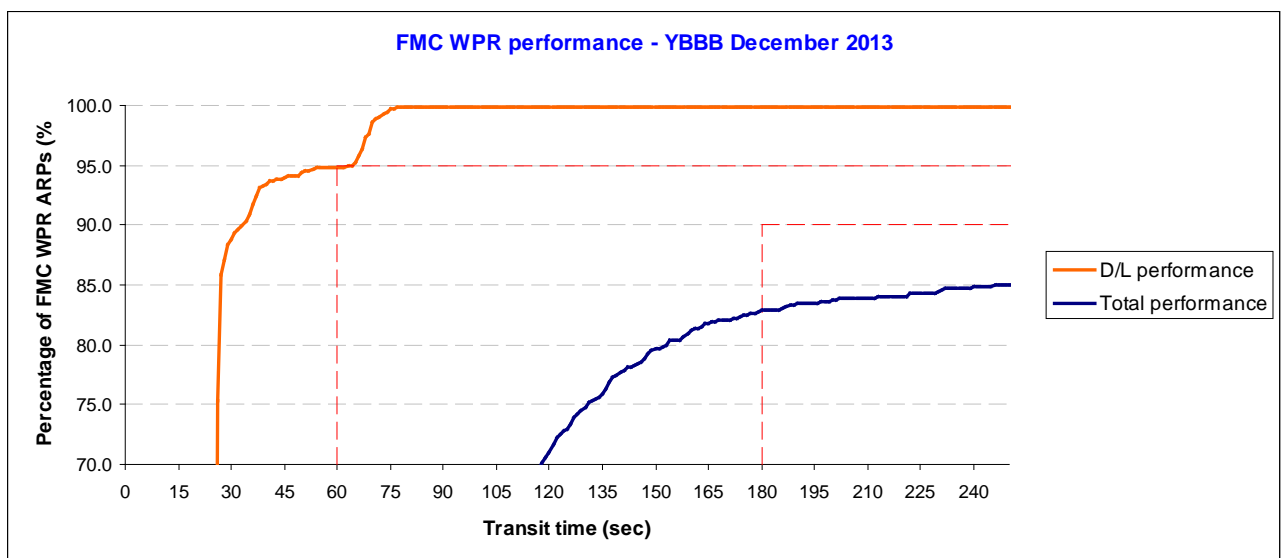
Fig 1. FMC WPR performance

2.4.5.1 The following graph provides an indication of the performance of FMC WPR in YBBB during December 2013.

2.4.5.2 In Fig 1, the red line provides an indication of the network (including AFTN) performance, whilst the blue line includes both the network and the flight crew delays in entering the required data and sending the report.

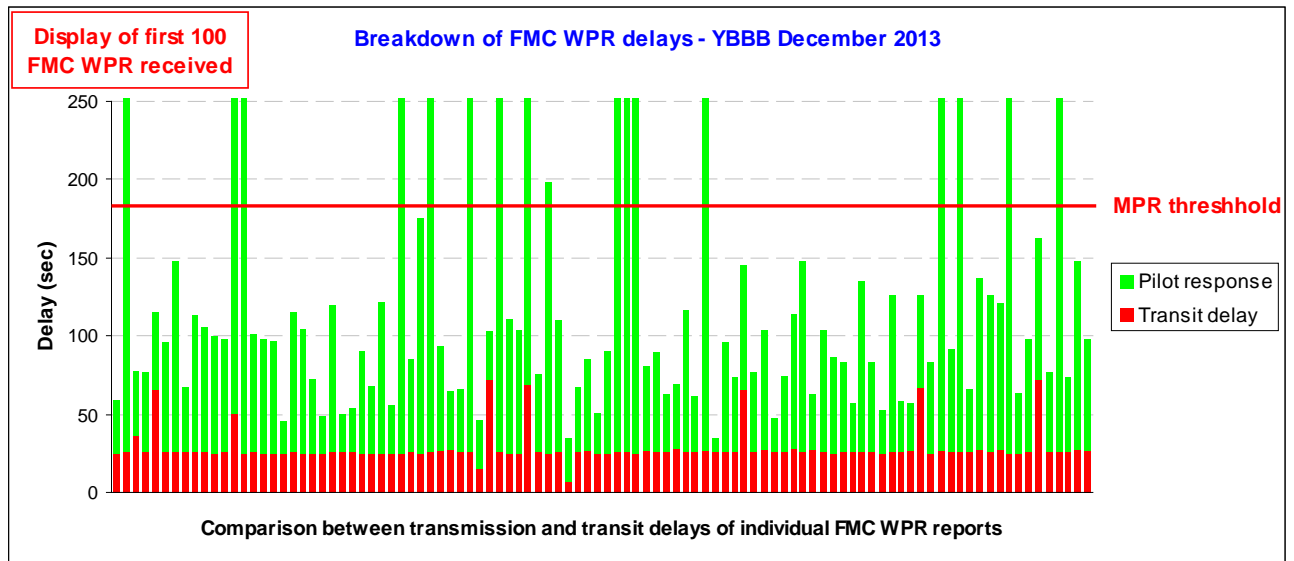
**Fig 2. Comparison of flight crew and transmission delay**

2.4.5.3 As can be seen, in Figure 2, the (unavoidable) flight crew delay makes up a significant component of the total delay.

2.4.2.2 The “transit time” is determined by comparing the FMC time stamp in the AFTN position report (highlighted in the first example) with the time of receipt of the report by the communications centre. By way of comparison, the transmission delay of FMC WPR is typically of the order of 20 to 25 seconds (see Figure 2 below).
