**Thirty Eighth Meeting of the
Informal South Pacific ATS Coordinating Group
(ISPACG/38)**

**Thirty First Meeting of the
FANS Interoperability Team
(FIT/31)**

Future Air Navigation System (FANS) Problem Report (PR) Briefing

Presented by the Central Reporting Agency (CRA)

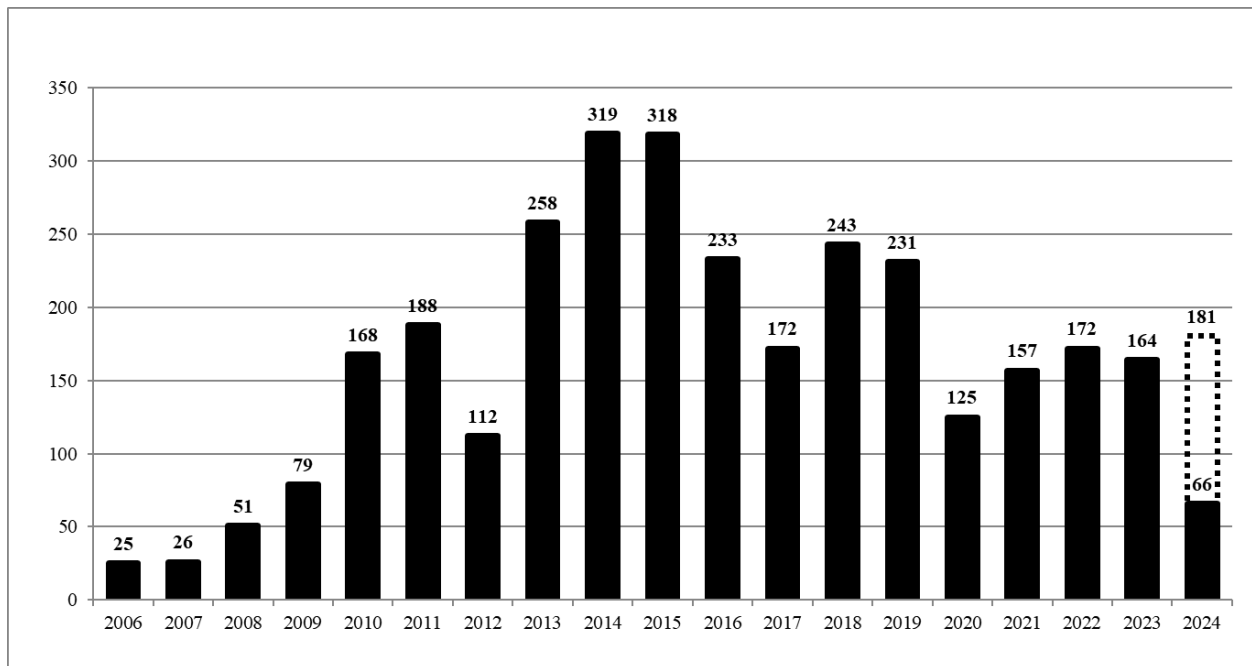
Figure 1 FANS PRs Per Year

- 1.3 Figure 1 illustrates the number of PRs that FANS stakeholders submitted per calendar year starting in 2006. The dotted line and associated number in the figure represent a linear projection of the number of PRs that will be submitted in 2024.

- 1.2 Between preparation of the previous FANS PR briefing for the FIT/30 meeting held in April 2023 and preparation of this FANS PR briefing in May 2024, FANS stakeholders submitted 183 PRs via the website, of which 26 PRs (14%) occurred in the South Pacific area. For comparison, the previous FANS PR briefing indicated that FANS stakeholders submitted 98 PRs, of which 21 PRs (21%) occurred in the South Pacific area.
